Sea Engineering, Inc.

MEMORANDUM

DATE: August 1, 2024 SE Project #: 25956

PROJECT: Hilo Wastewater Treatment Plan Outfall Inspection

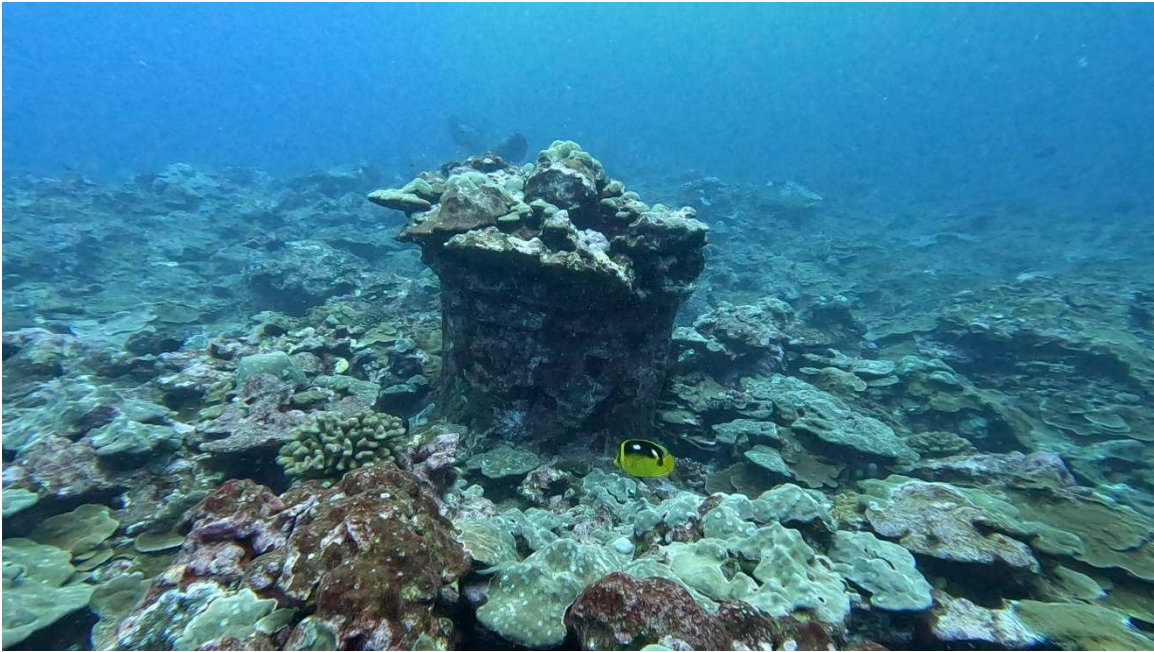
- Manhole #4A located at Sta. 44+63, marked the end of the diffuser leg and the visible portion of the outfall, with no visual evidence of leakage. The manhole is situated at a water depth of approximately 52 feet. The termination of the outfall, including the end pipe at Sta. 44+68, was not visible due to extreme coral cover (Figure 7).

Figure 7. Manhole #4A, located at Station 44+63, shown with high coral cover and outfall pipe covered

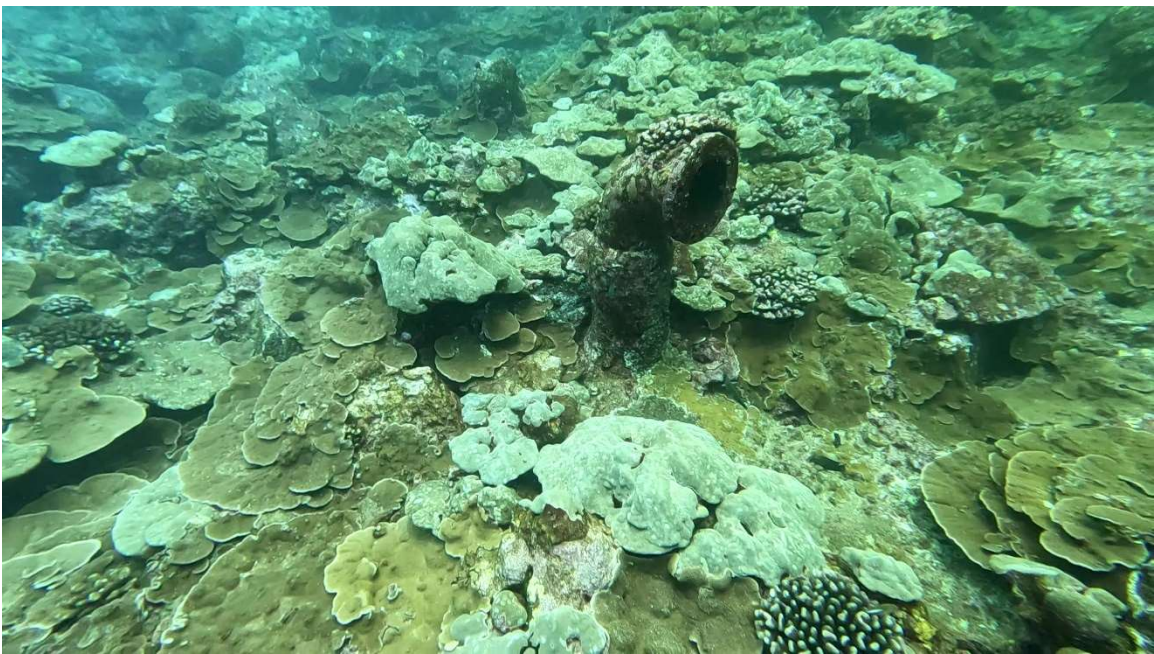
- Moving shoreward from Manhole #A4, is the diffuser field, where there are 15 individual ports staggered along the diffuser leg with Stationing from 44+53 to 42+43. Similar to previous visual inspection survey in 2018, the 6 most seaward ports appeared to be obstructed with no discharge of effluent (Figure 8), while the 9 most landward ports were observed discharging the dye infused effluent (Figure 9). Manhole #A3 located at the start of the diffuser leg (Figure 10) was found with no evidence of leakage.

Figure 8. Typical diffuser port with no discharge of dye

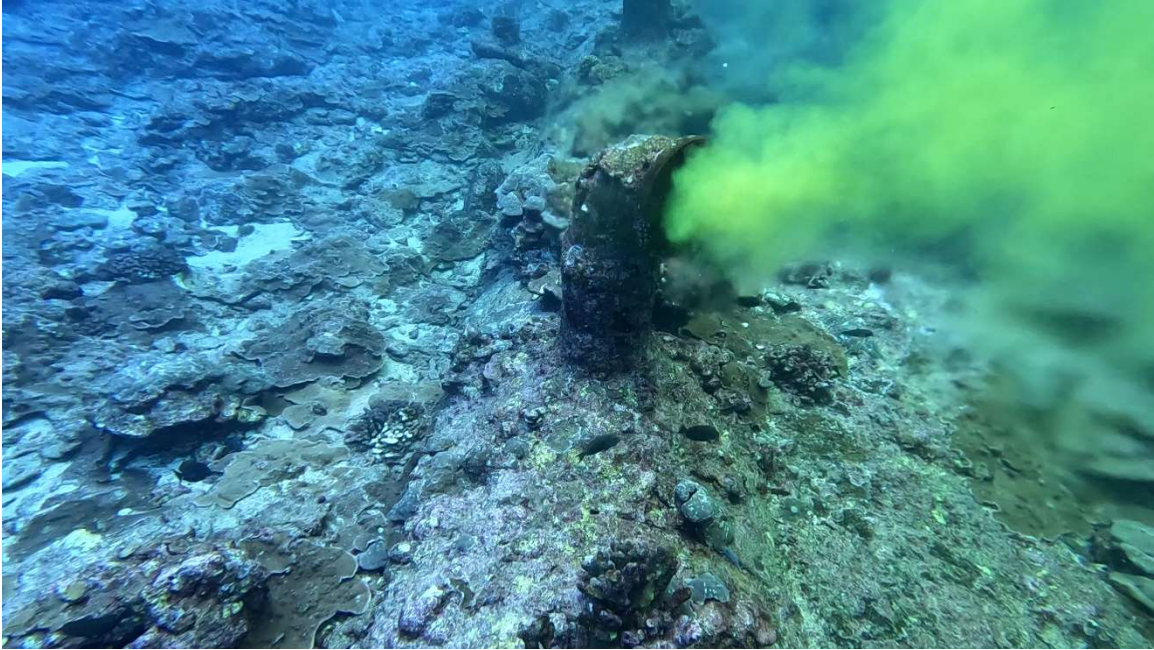
Figure 9. Typical diffuser port with discharge of dye

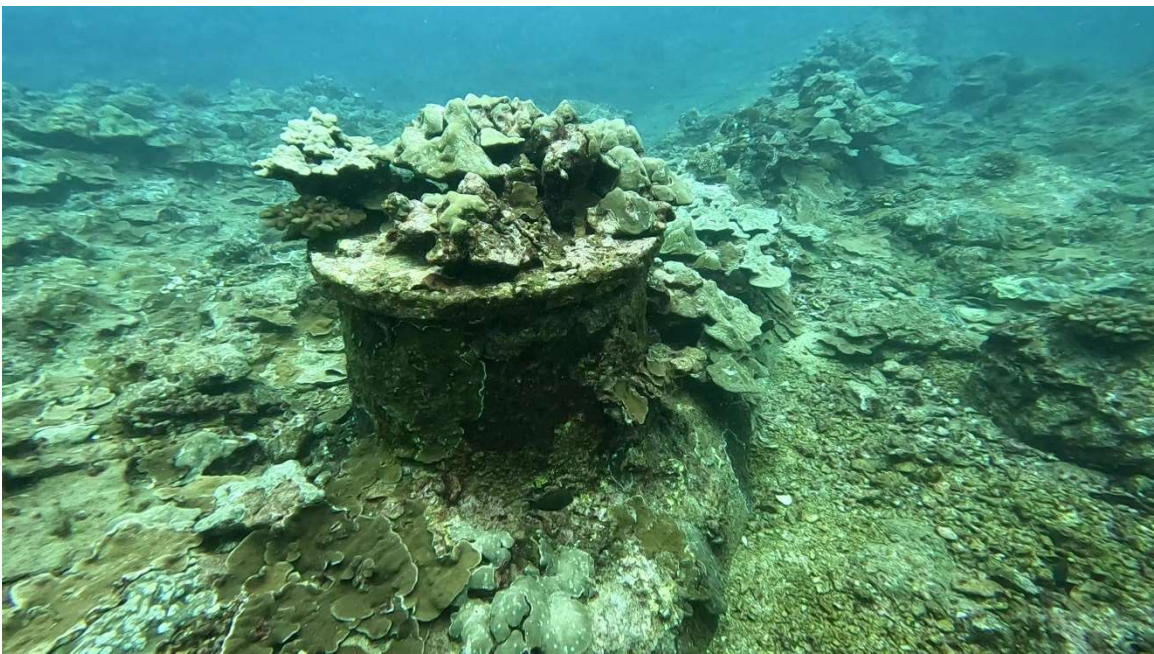
Figure 10. Manhole #A3 located at Station 42+23, with extensive coral cover but visible outfall pipe

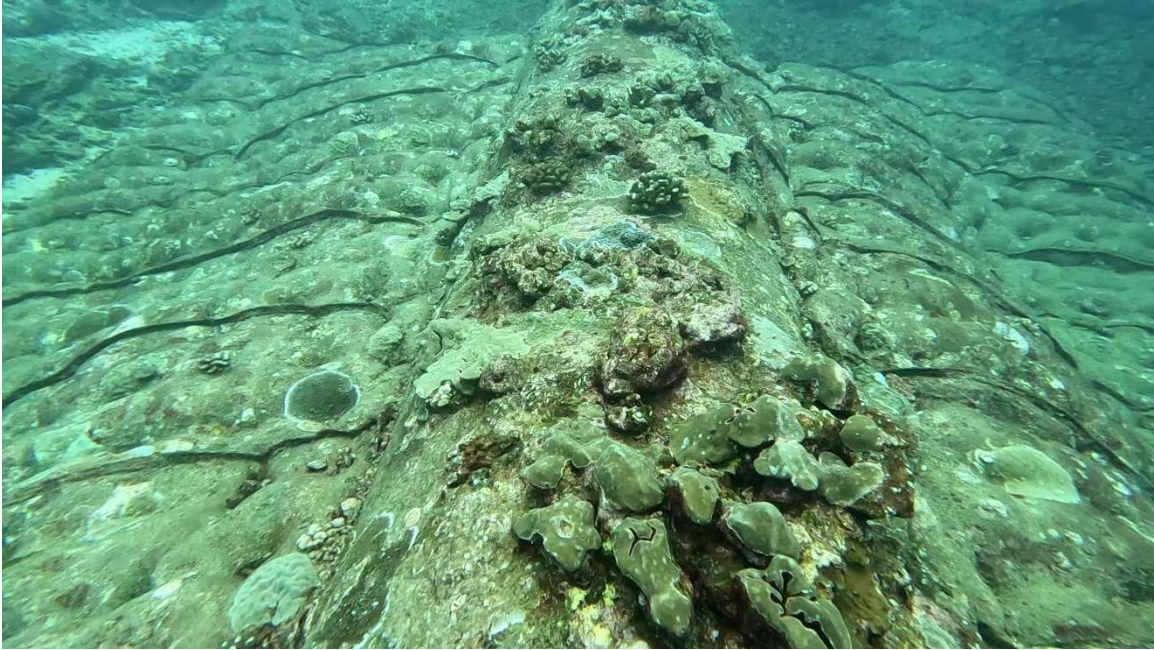
- Between manholes #A3 and #A2, the main barrel of the outfall is visible with dense coral growth. The 2016 repairs of eroded or undermined seafloor on the outfall corridor with concrete fabric forms were observed by divers with no visible damage (Figure 11).

Figure 11. Outfall pipe with concrete mattress repairs performed in 2016, Stationing 41+92 to 41+54

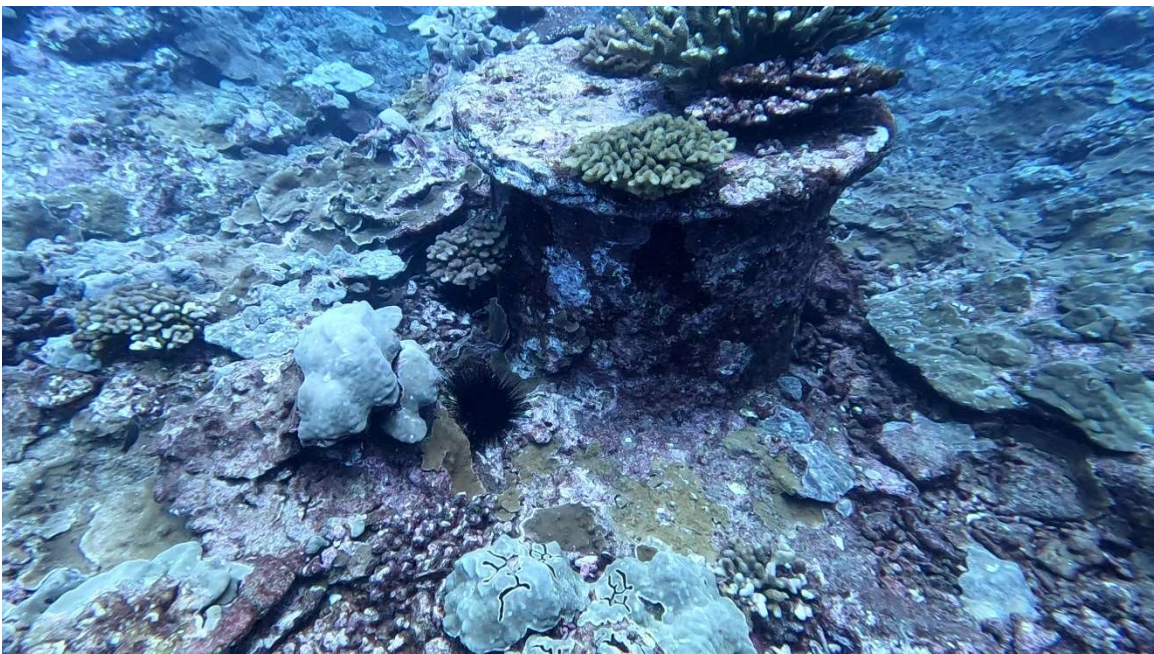
Manhole #A2 is observed with dense coral growth (Figure 12). No leakage was visible for either manhole.

Figure 12. Manhole #A2 located at Station 39+78 with coral cover but visible outfall pipe

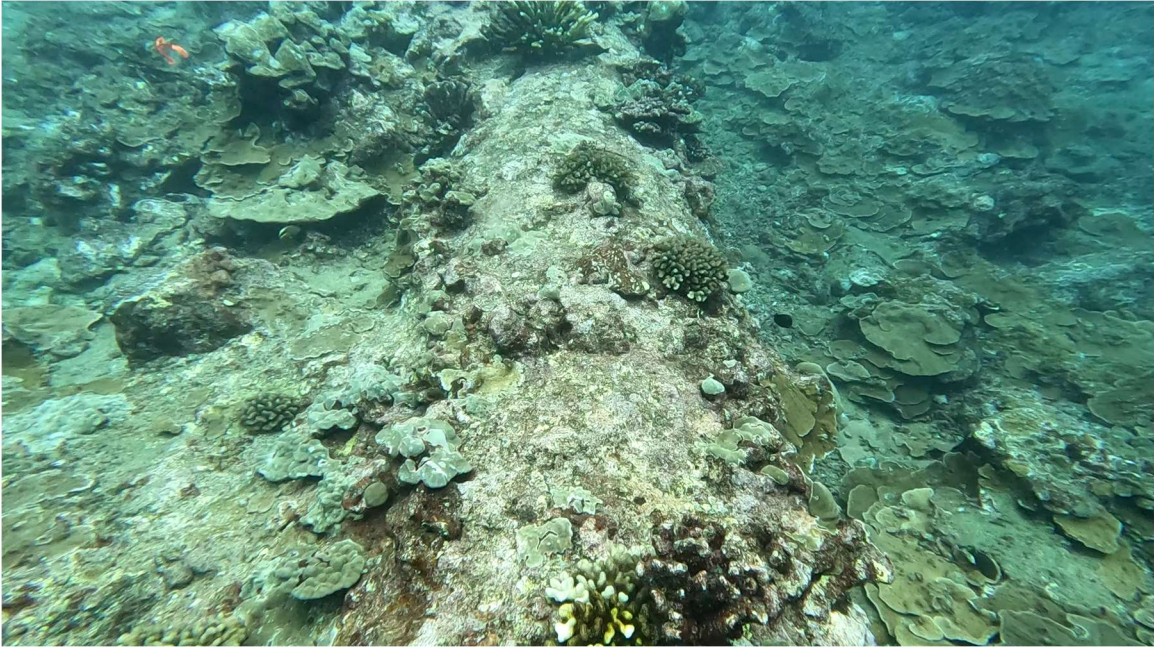
- Between manhole #A2 and #A1 the outfall pipe is visible with dense coral growth. Some limited sections of scoured seafloor adjacent to the pipe were observed, (see Figure 13 and Figure 14), however no significant changes were seen when compared to the most recent 2018 inspection results at those same locations. It has also been noted in previous inspection reports that, because the outfall pipe is exposed at these locations and the seafloor appears to be erodible in places, this portion of the outfall corridor is thought to be potentially more vulnerable to future damage from wave action. Manhole #A1 is observed with sparse coral growth (see Figure 15) and no leakage.

Figure 13. Section of outfall with scour on one side near Station 39+15

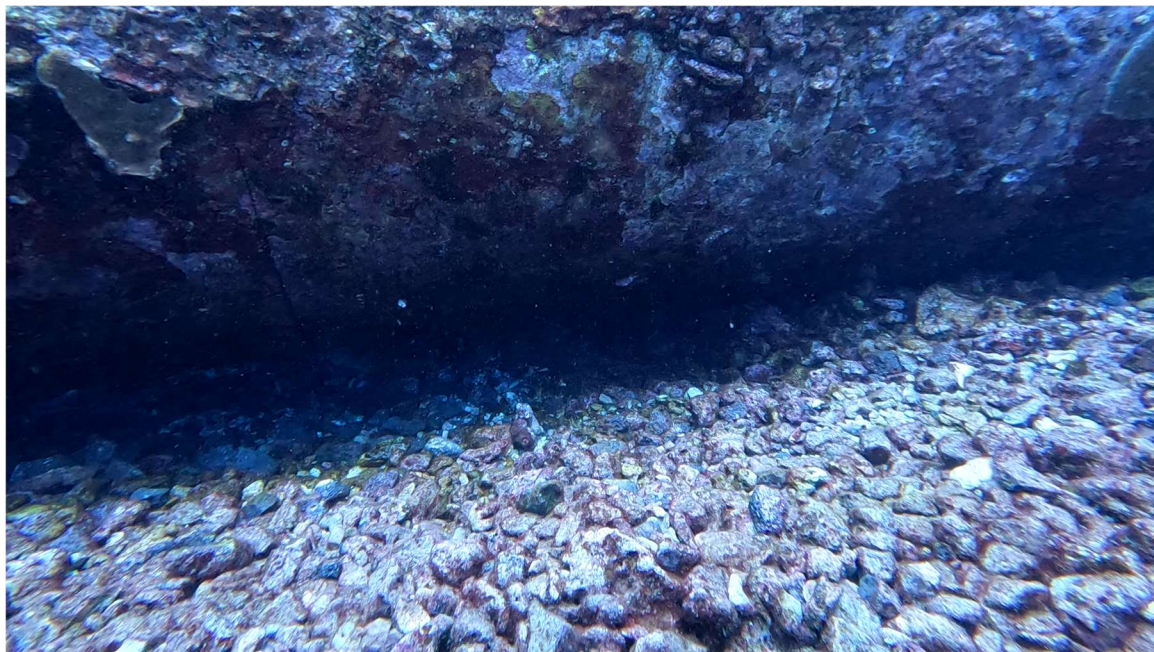
Figure 14. Section of outfall found with scour on both sides, vicinity of Station 33+15

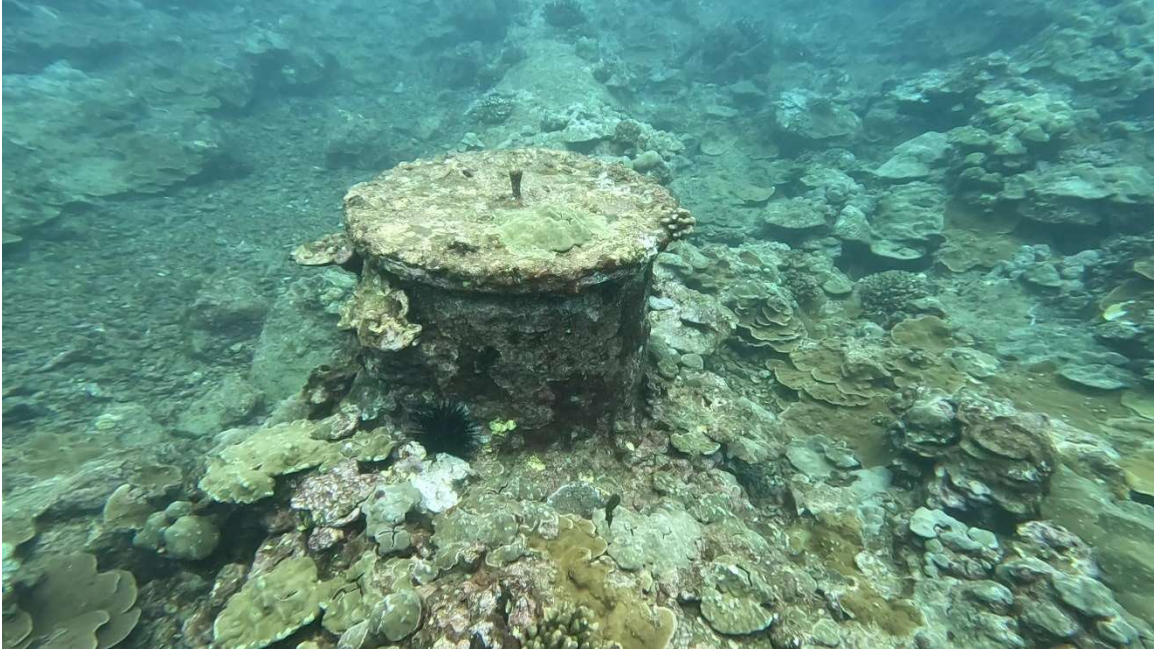
Figure 15. Manhole #A1 located at Station 30+95 with coral cover but visible outfall pipe

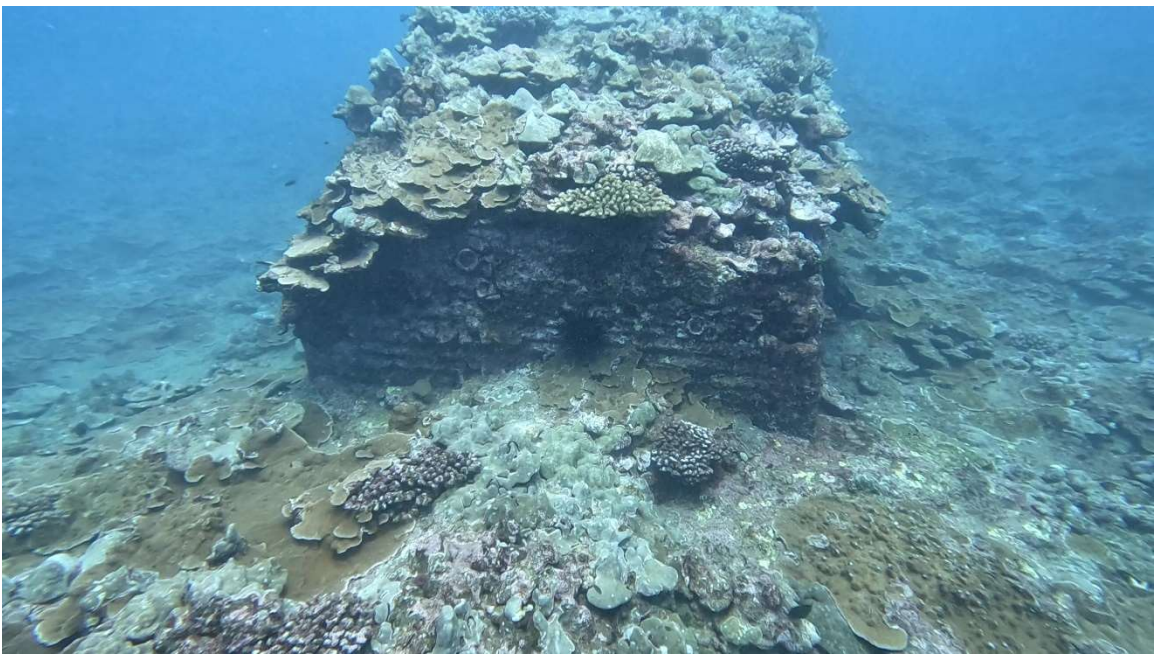
- The concrete anchor block located inshore of manhole #A1 was observed with extensive coral growth on the top surface (Figure 16). Manhole #2 was seen further inshore of the anchor block at Station 25+88 (Figure 17). No evidence of leakage was found for either manhole.

Figure 16. Concrete armor block located at Station 29+55 to 28+46

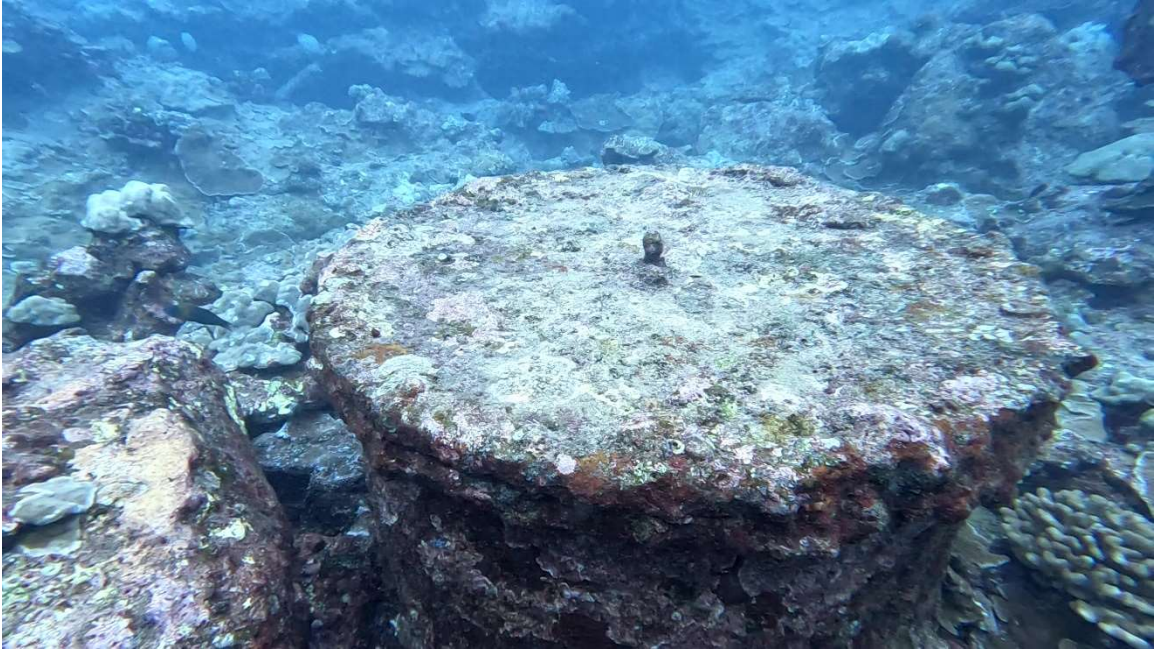
Figure 17. Manhole #2 located at Station 25+88 with no coral cover

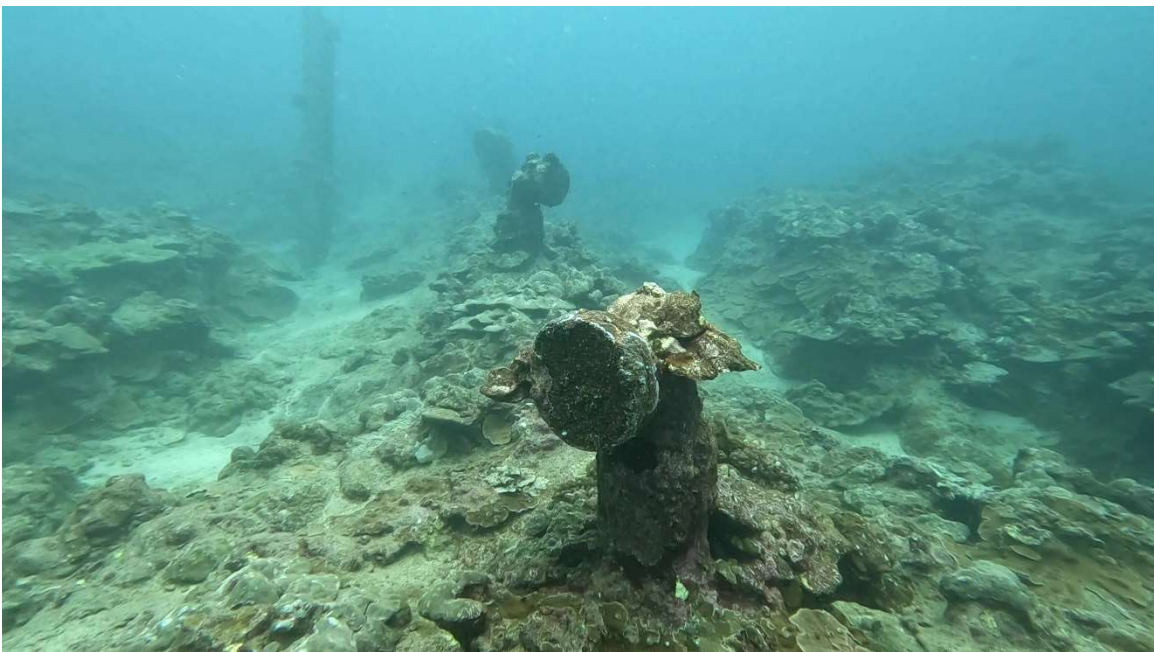
- The non-operational diffuser field from the original outfall construction were observed shoreward of manhole #2, running from Station 23+63 to 25+88. All decommissioned diffuser ports were capped with blind flanges (Figure 18), with no visible leakage.

Figure 18. Typical view of original diffuser ports and riser landward of manhole #2 with blanked port flanges visible

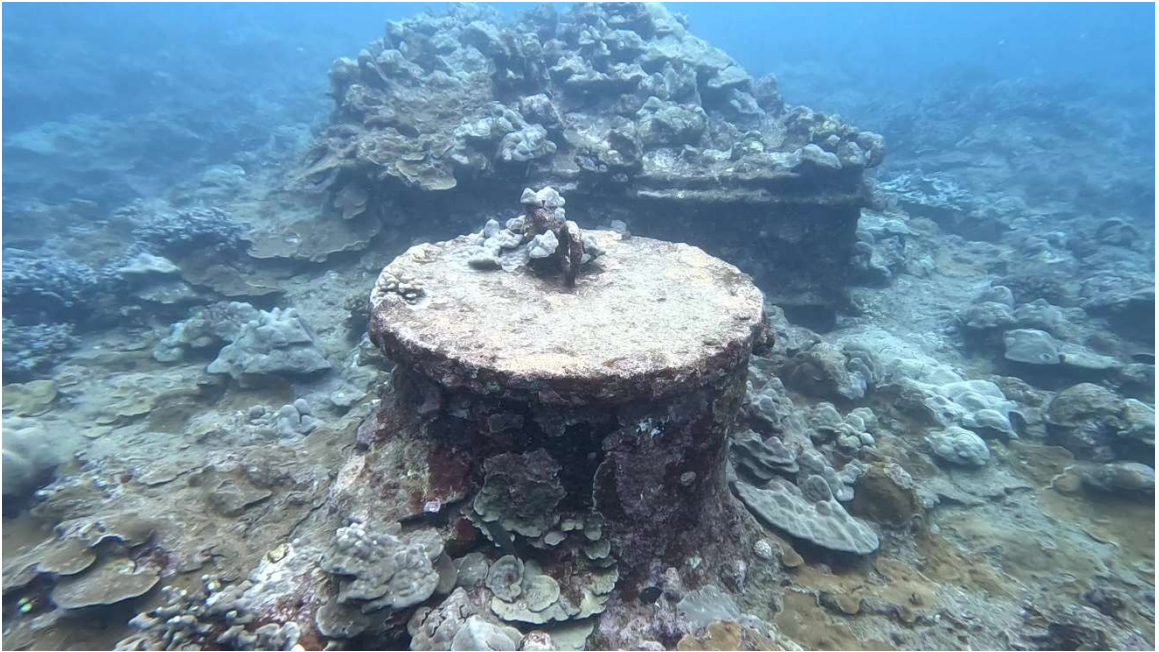
- Manhole #1 and the outfall bend are located between Station 9+90 and 9+80 (Figure 19), respectively. The manhole and riser were visible at this location, and appeared to be in good condition with no visible leakage.

Figure 19. Manhole #1 located at Station 9+90 and outfall pipe bend located at Station 9+80

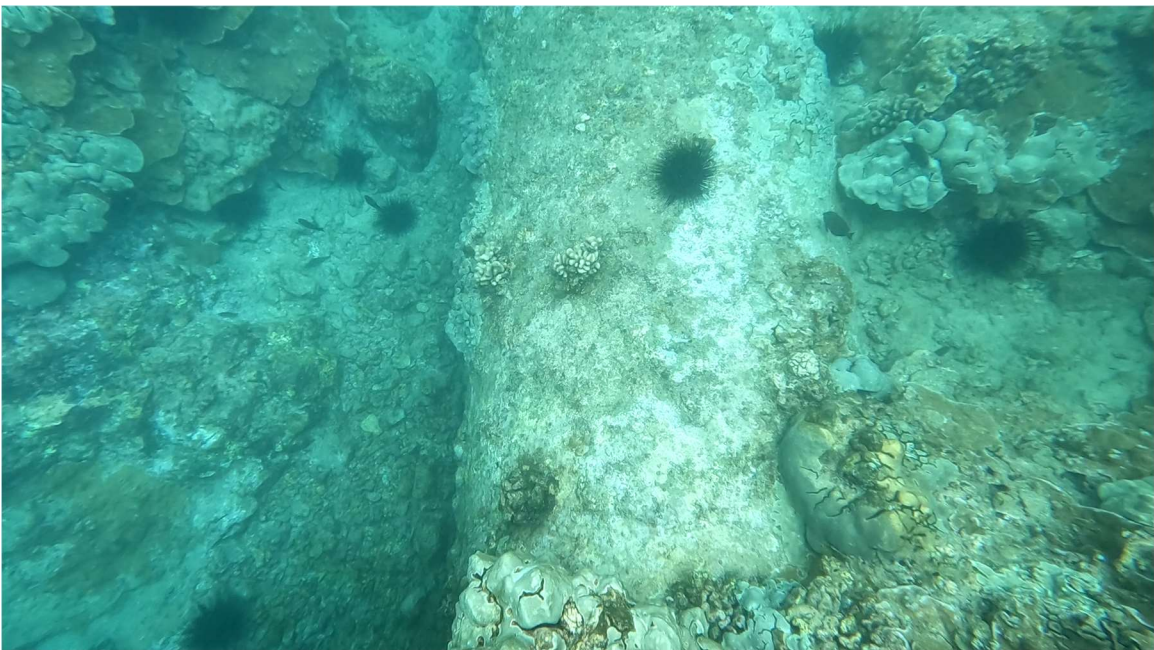
- Landward of the bend, inspectors noted intermittent sections of limited scour located between Stations 6+00 and 2+00, typically less than 10 feet in length along the flank of the exposed pipe (see Figure 20). These areas appeared consistent with the latest inspection results, with minimal change.

Figure 20. Typical outfall pipe scour observed between the bend and shoreline
